Jasper Strategic Facility Plan Municipality of Jasper • May 2024

Executive Summary

This section provides a summary of the functional and building condition assessment findings conducted per building. It provides high level information on observed concerns and provides recommendations to rehabilitate, upgrade, or replace building components. The building condition assessment highlights critical items requiring immediate attention however non-urgent recommendations can be found in the appendix.

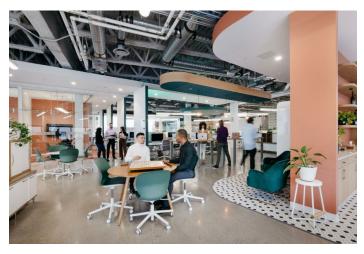
Amii event and collaboration space

A recent success with hot desking was the Amii Event and Collaboration Hub, completed in 2022 in Edmonton. Pods or 'banks' of desking were designed, each with it's own storage for teams and collaborative whiteboard wall. This flexible strategy has successfully facilitated rotating groups of users in amii's space. Each station is outfitted with a height adjustable desk, an ergonomic chair, and an adjustable plug-and-play monitor system.

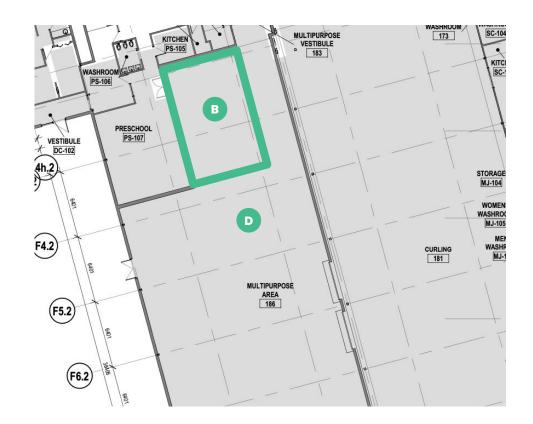
◆ Diagram indicating suggested location of additional storage space for daycare in Activity Centre within the gymnasium

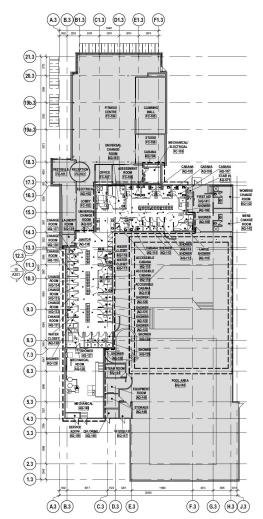
Fitness and Aquatic Centre Main Floor Plan

The fitness and aquatic centre is majorly occupied by a main pool area, a fitness centre, the climbing wall area and the future universal change rooms that consist of individual change rooms, showers, and cabanas. Other supporting programming include the reception area, lobby area, an office, a first aid station and a studio. The building includes support spaces such as utility rooms, equipment rooms, storage rooms, and a laundry room.

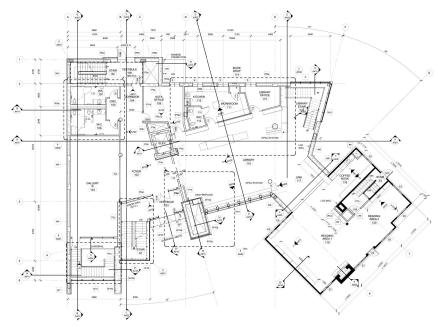
Library and Cultural Centre Main Floor Plan

The building hosts a variety of programming serving users including children, teens, and the general public.

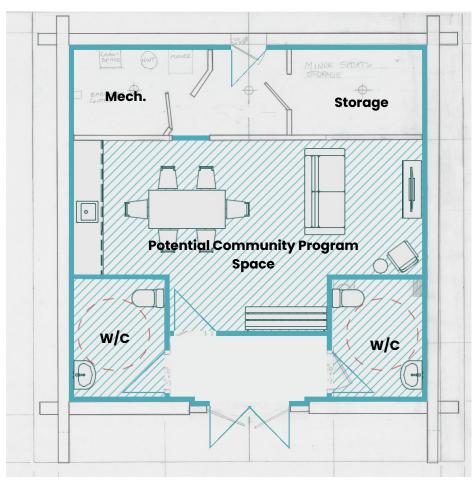
The below sketch demonstrates the opportunity to convert the cabin for additional programming so that it is more efficiently utilized. It is important to note that this recommendation is not to replace the current functionalities it serves and is more to showcase opportunities for additional space utilization.

▲ Diagram of space reconfiguration recommendations in the Log Cabin

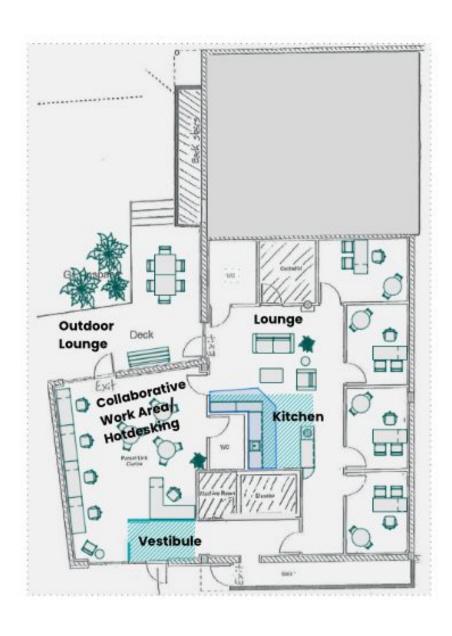
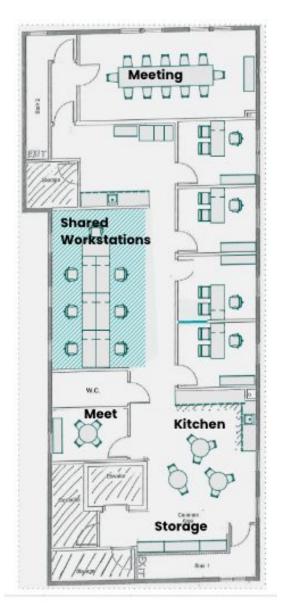
MAIN FLOOR

The below sketches demonstrates some opportunities to reconfigure each floor to promote space efficiency and supporting workspaces. They include an emphasis on hot desking and casual seating to support staff and visitors who are only in the space for shorter periods of time and therefore create opportunities for full time staff and mobile staff.

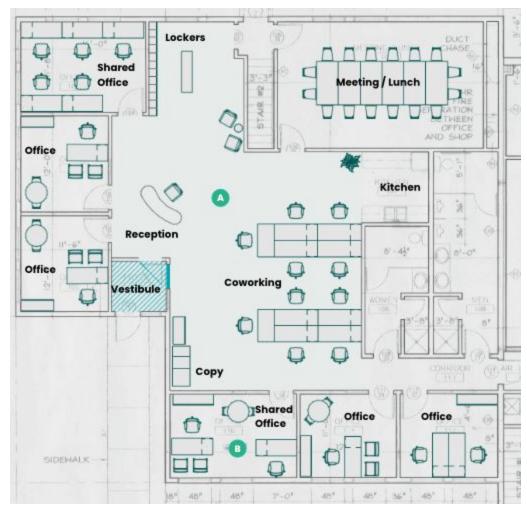
▲ Diagram of space reconfiguration recommendations on the Main Floor of the Operations and Utility Shop office space.

The next two sketches demonstrate the possible opportunities within the existing space through reconfiguration/addition of furniture to optimize the potential of areas that are currently underutilized as a result of the functional assessment.

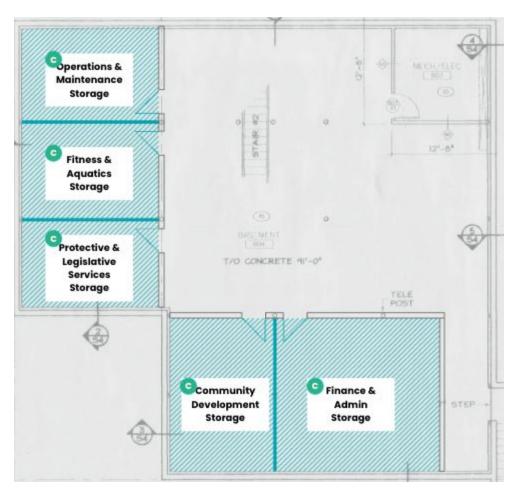
▲ Diagram of space reconfiguration recommendations on the Basement of the Operations and Utility Shop office space. This storage solution would serve several departments. In order to install this storage, fire safety systems will need to be addressed.

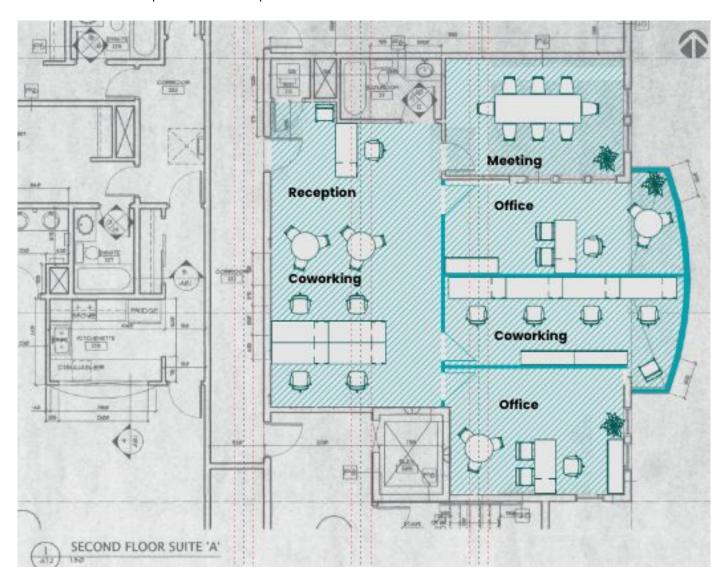
The below sketch demonstrates the opportunity to convert the second floor apartment into additional working spaces. It is important to note that the existing mechanical system should be reviewed to ensure sufficient ventilation services are provided for the space in the future.

▲ Diagram of space reconfiguration recommendations for the Second Floor Apartment suite in the Emergency Services Building

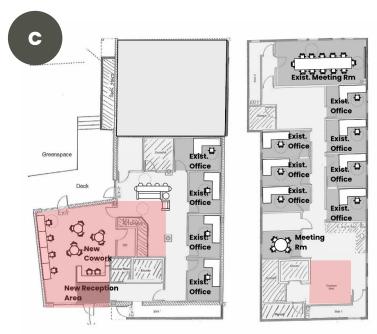
Consolidate Corporate Functions at Patricia Street: Minimal renovations at Patricia (heavy/light values provided), which can include the relocation of the reception to the main floor, conversion of the parent link space into open workstations, conversion of kitchen into an additional office space, conversion of common area into another workstation and general interior finishes such as paint.

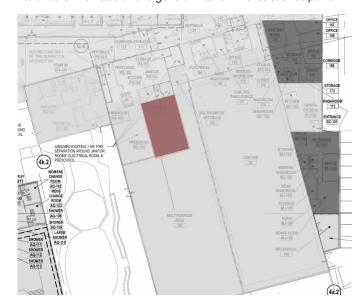
Expand Storage Space: Conversion of a section of the multipurpose space in the Activity Centre into additional storage.
